APPENDIX A

Summary of Results from Winter 2010 Stream Flow Monitoring Program

Photographs of Monitoring Well Upgrade

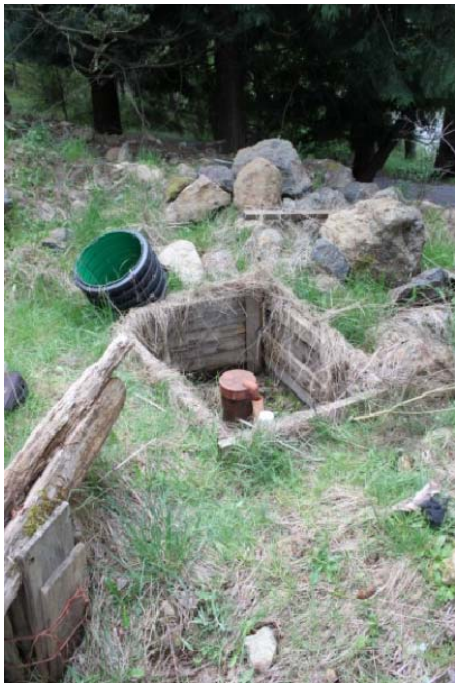
Photograph 1: Pre-existing condition of monitoring well DOH-04A. The well was completed in a well pit and the casing did not extend a minimum of 0.3 m above the floor of the pit, as required under the BC Ground Water Protection Regulation.
